Quality Assurance and Source Inspection

Contract #: 04-0120F4Cty: SF/ALA Rte: 80 PM: 13.2/13.9File #: 82.28**WELDING INSPECTION REPORT****Resident Engineer:** Siegenthaler, Peter**Address:** 333 Burma Road**City:** Oakland, CA 94607**Report No:** WIR-017430**Date Inspected:** 09-Oct-2010**Project Name:** SAS Superstructure**OSM Arrival Time:** 700**Prime Contractor:** American Bridge/Fluor Enterprises, a JV**OSM Departure Time:** 1530**Contractor:** Westmont Industries**Location:** Santa Fe Springs, CA.**CWI Name:** R. Rodriguez, R. Dominguez**CWI Present:** Yes No**Inspected CWI report:** Yes No N/A**Rod Oven in Use:** Yes No N/A**Electrode to specification:** Yes No N/A**Weld Procedures Followed:** Yes No N/A**Qualified Welders:** Yes No N/A**Verified Joint Fit-up:** Yes No N/A**Approved Drawings:** Yes No N/A**Approved WPS:** Yes No N/A**Delayed / Cancelled:** Yes No N/A**Bridge No:** 34-0006**Component:** Travelers**Summary of Items Observed:**

SAS-EB Traveler

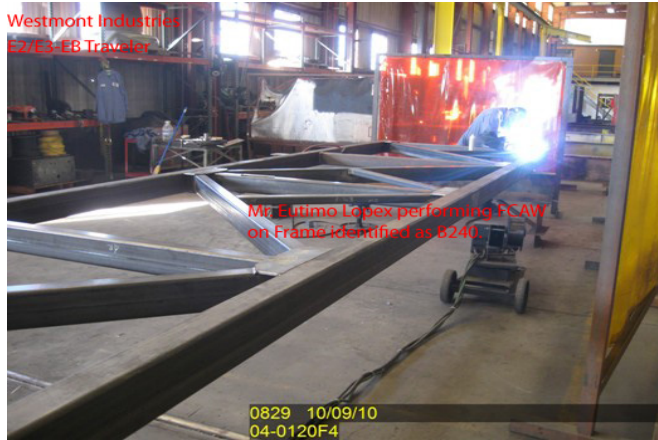
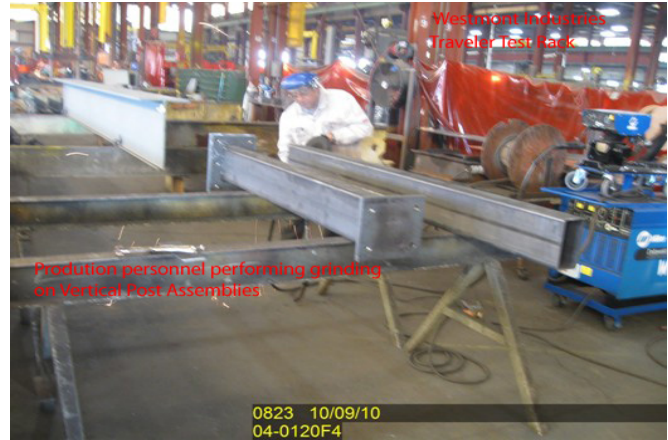
On this date, the QA Inspector observed Westmont Industries (WMI), production welder Jose Rodriguez (WID # 3031) continuing to perform Flux Core Arc Welding (FCAW) activities, for the Trolley Test Stand. The QA Inspector observed that Mr. Rodriguez was performing the FCAW in the 2F (horizontal) position and the fit up appeared to be a T joint, with an 8 mm fillet weld reinforcement, per the approved shop drawings. The QA Inspector observed that the FCAW was being performed on the piece mark identified as Rail X flange to web plate, per the shop drawing # WMI-TTC-4. The QA Inspector then utilized a Bridge Cam Gauge to measure random sections of completed weld and the fillet weld reinforcement appeared to be 10 mm.

See attached picture below.
